CHAPTER VI

HAZARD SCENARIO AND IMPACT OF NATURAL AND ANTHROPOGENIC FACTORS ESPECIALLY IN REGARD TO CLIMATE CHANGE IN THE SUBANSIRI AND THE ALAKNANDA BASINS

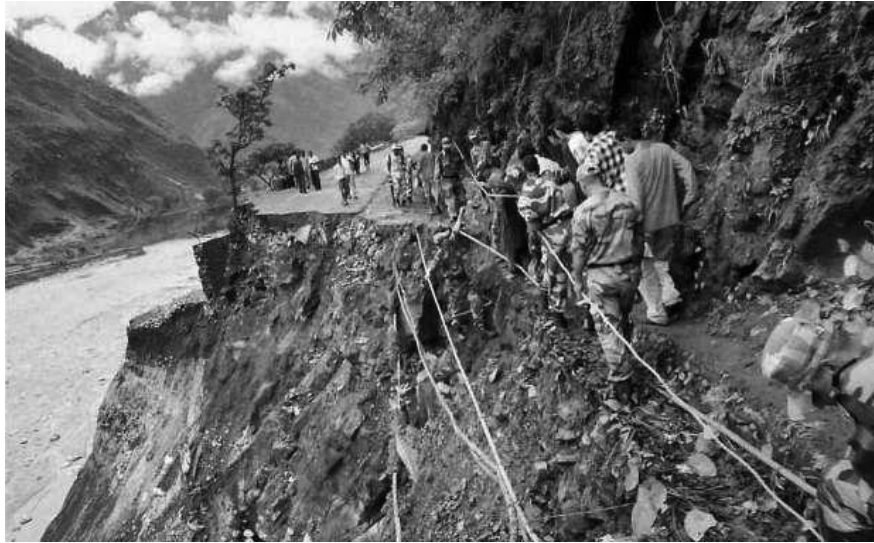
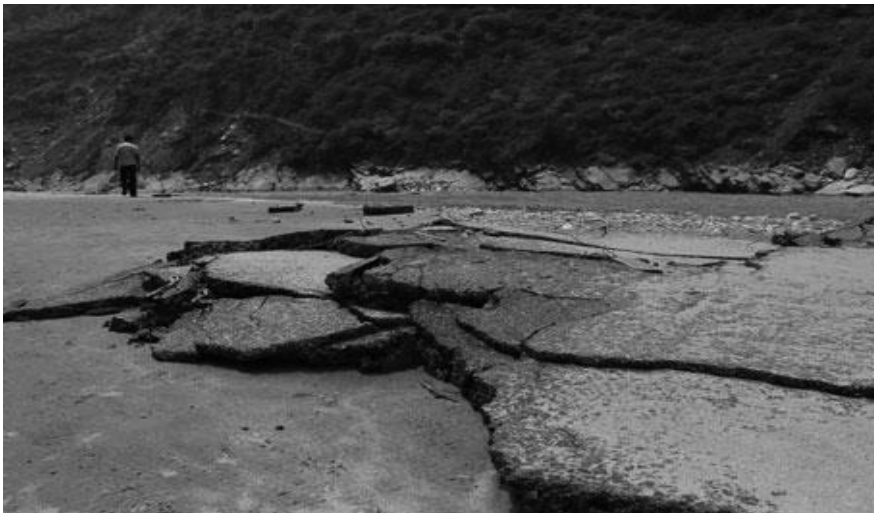
Plate 6.1: Uttarakhand disaster 2013 (Source: www.google.co.in)

The natural disaster that occurred in Kedarnath area of Uttarakhand in the month of June, 2013 is a classic example of flash floods and the biggest ever devastating in the state and also one of the biggest in the country, causing loss of thousands of human life and livestock. Plate 6.1 and 6.2 shows the devastation of Uttarakhand disaster, 2013.

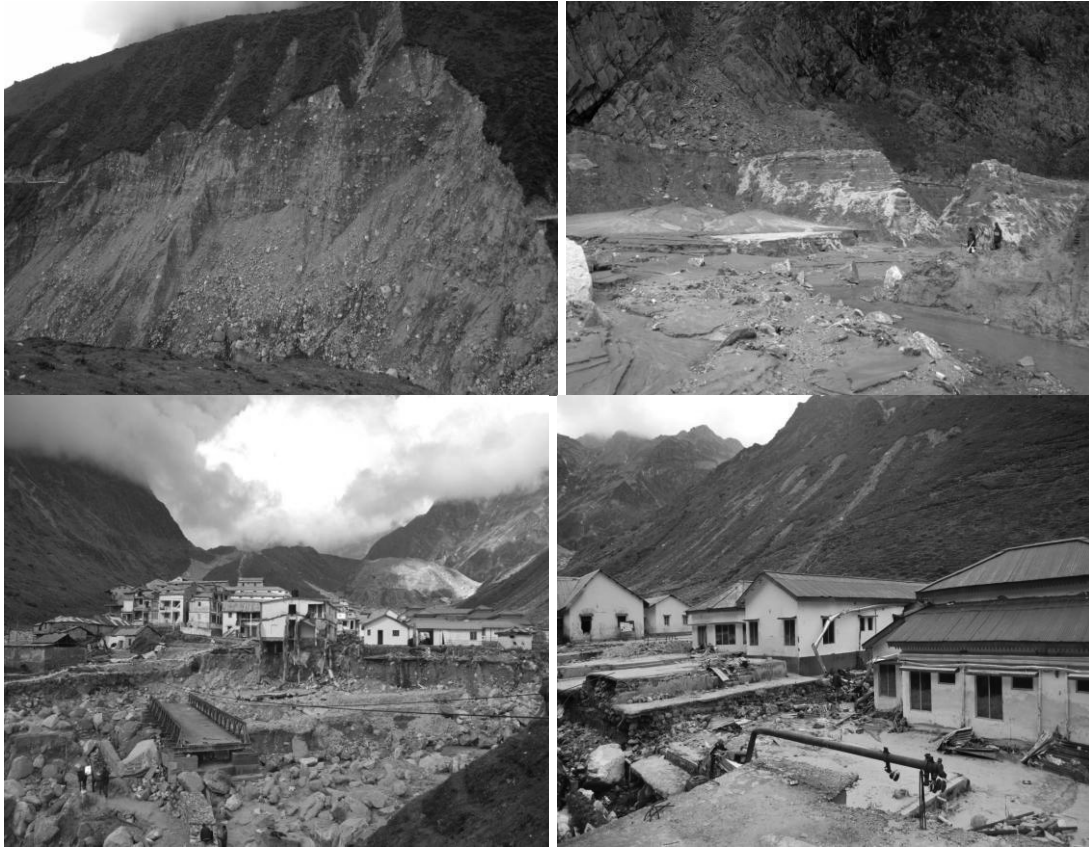
Plate 6.2 Devastation of Uttarakhand disaster 2013, in between Kedarnath and Chorabari Tal area

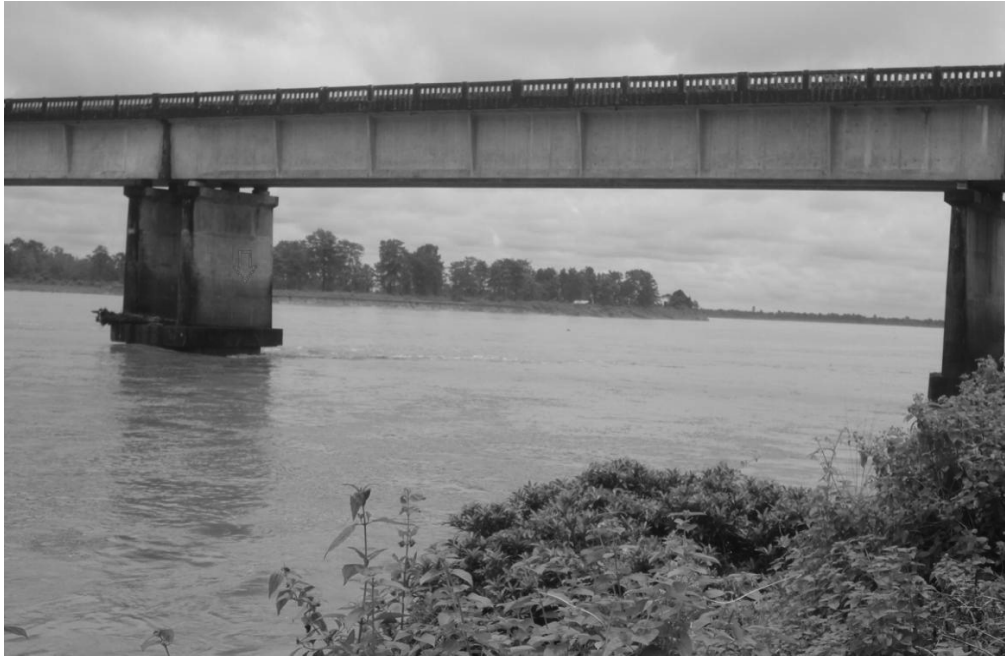
Plate 6.3: The red mark on the bridge pier indicates the highest flood level in the Subansiri river during 2012

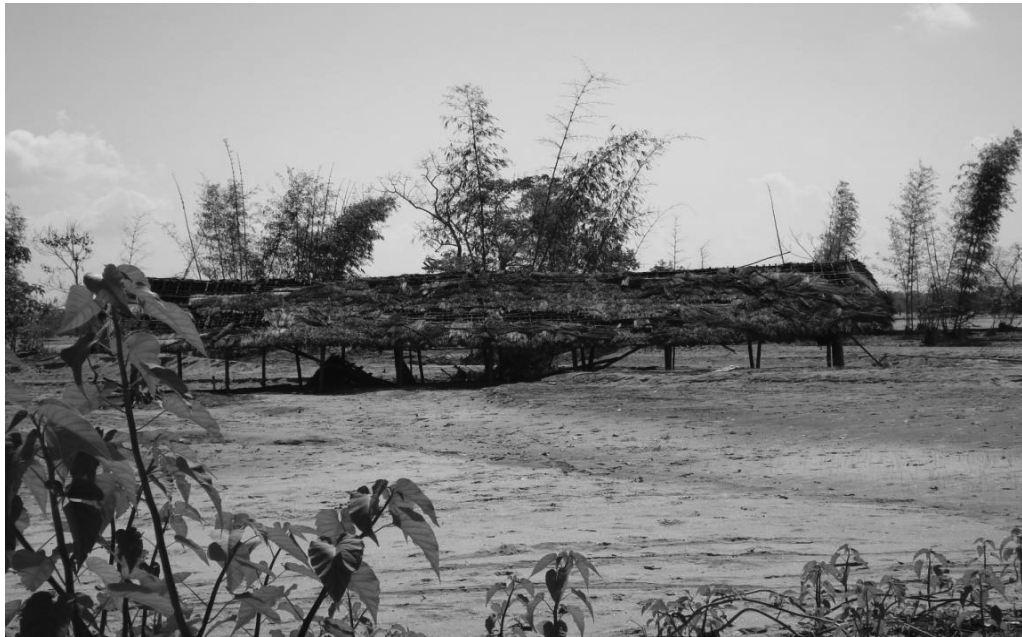
Plate 6.4: Siltation after flood at Matmora in the Subansiri basin

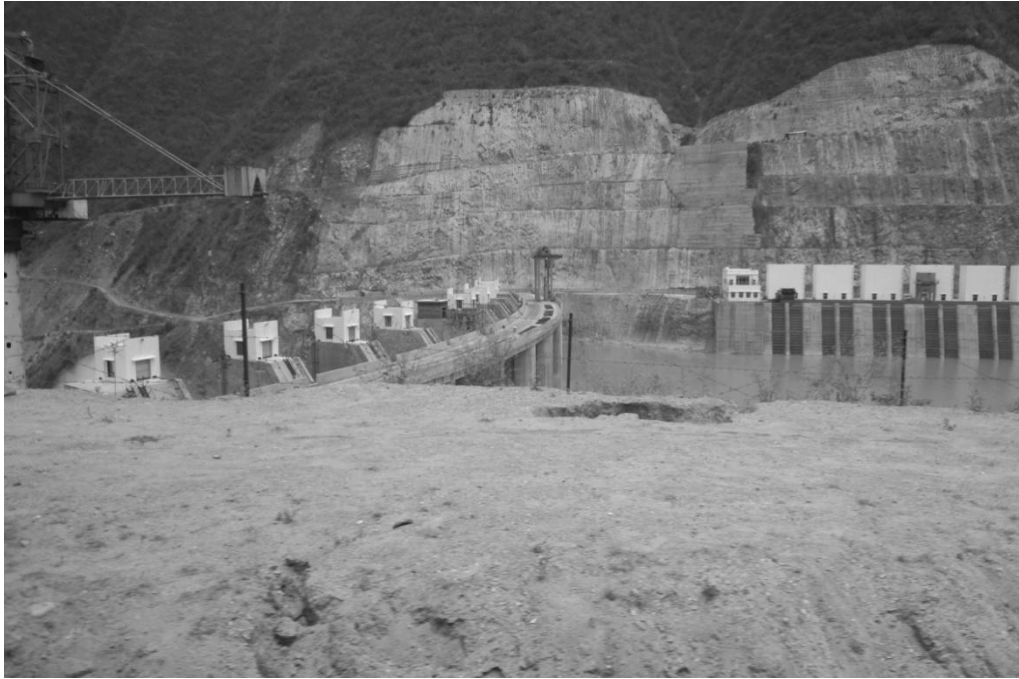
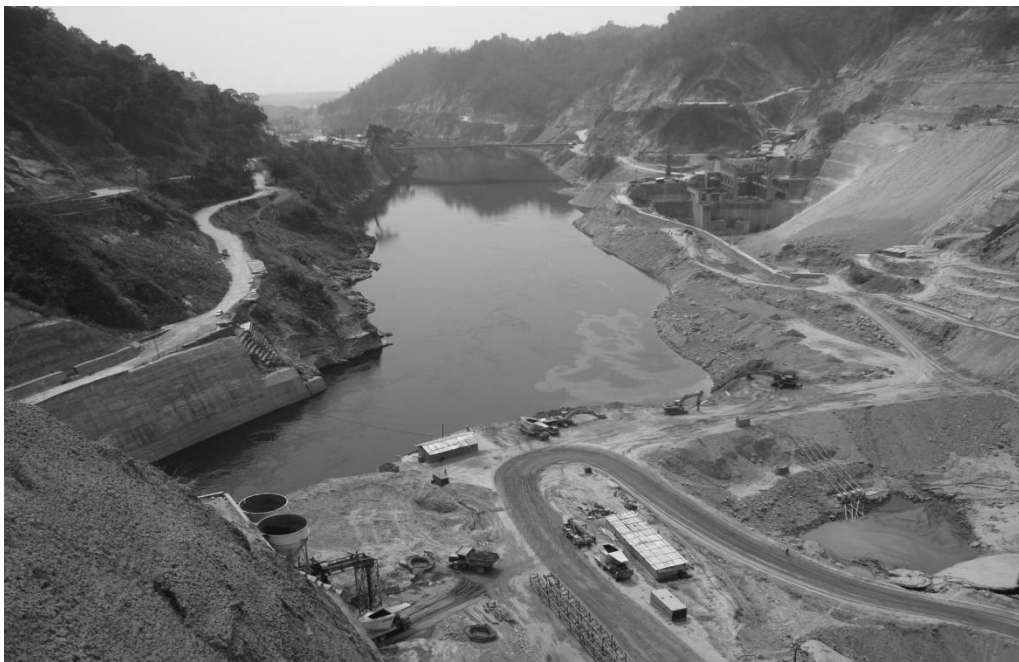
Plate 6.7: Construction of dams (a) in the river Alaknanda in Garhwal and (b) in the river Subansiri in Arunachal Pradesh

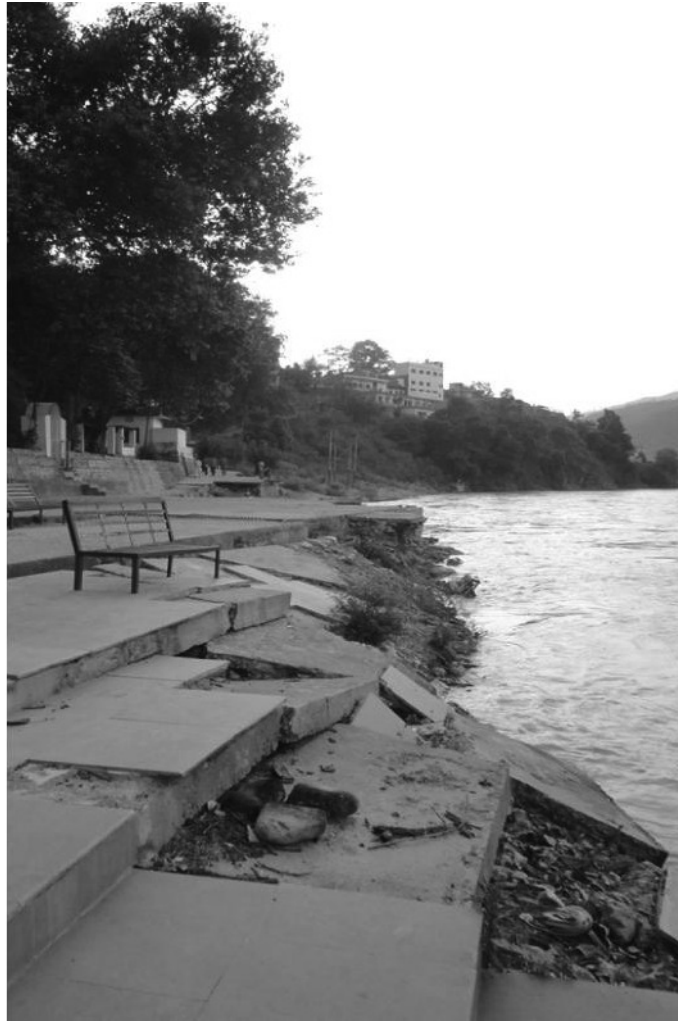
Plate 6.9: Devastation of Uttarakhand disaster 2013 in Srinagar near Ganga Ghat

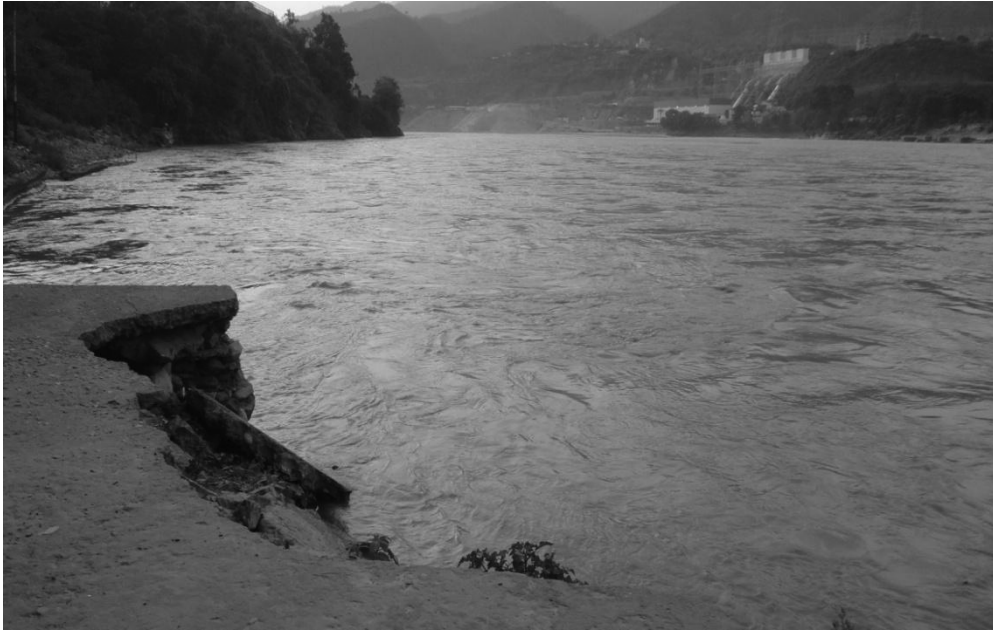
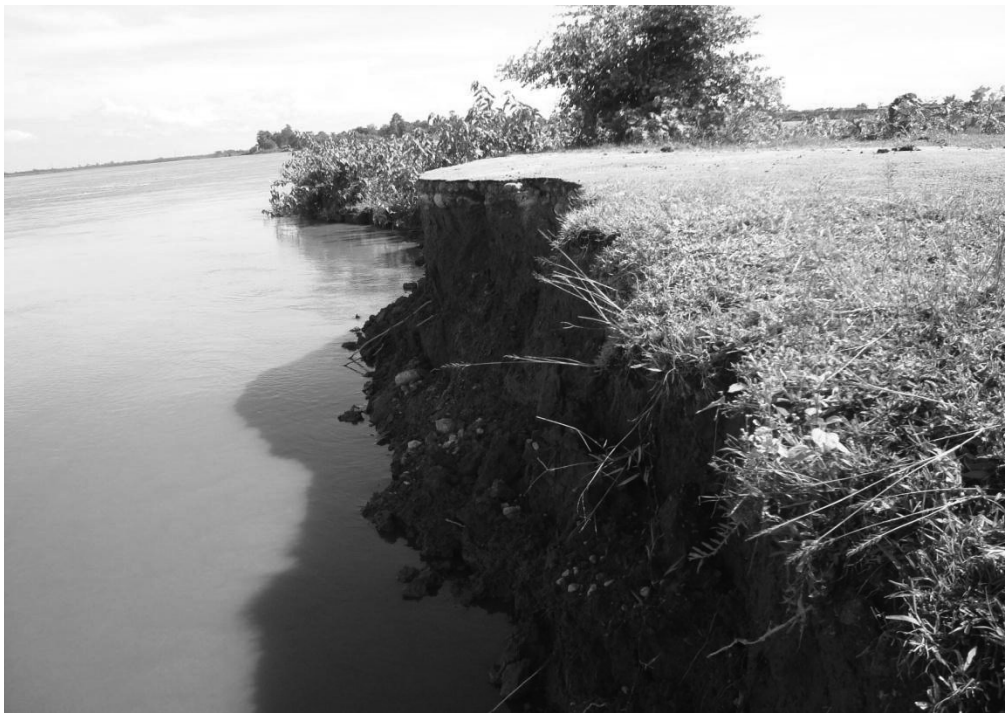
Plate 6.10: Bank erosion in (a) Srinagar during Uttarakhand disaster 2013 and (b) near Khabolughat in Subansiri basin during the flood of 2008

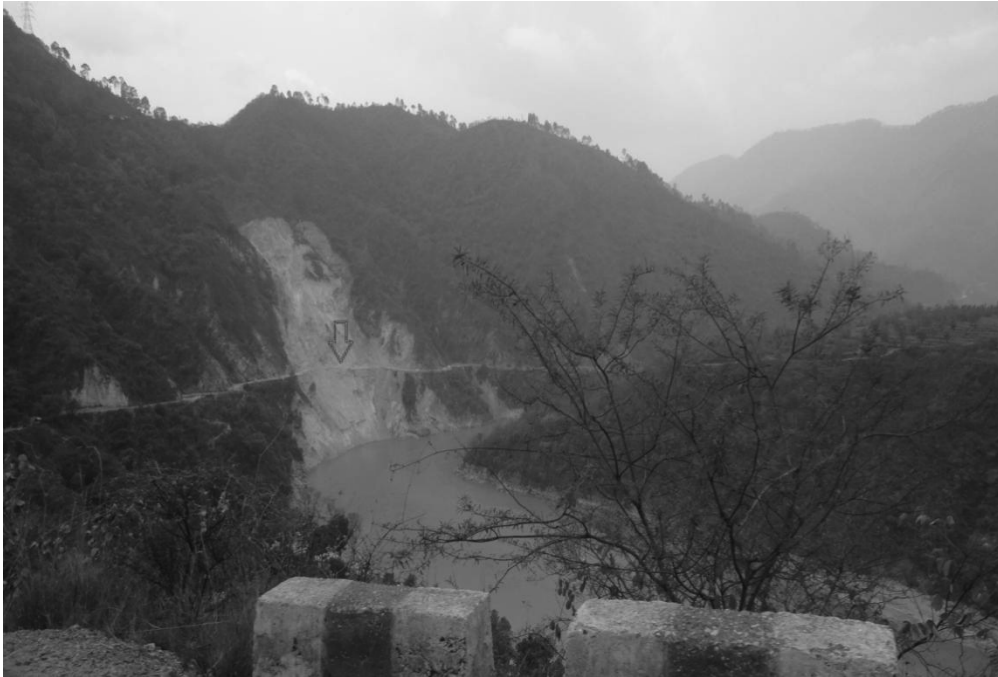
Plate 6.11: Red mark showing the destroyed road in Rudraprayag because of landslides during Uttarakhand disaster 2013

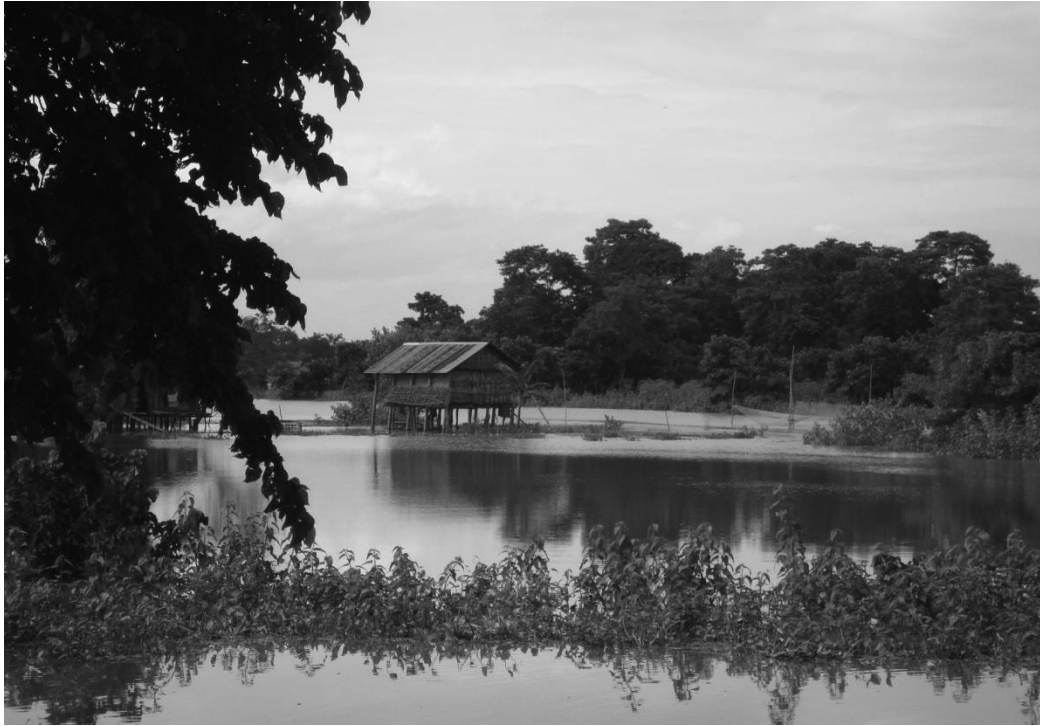
Plate 6.13: Submerged area of Khabolughat in Subansiri basin during the flood of 2008

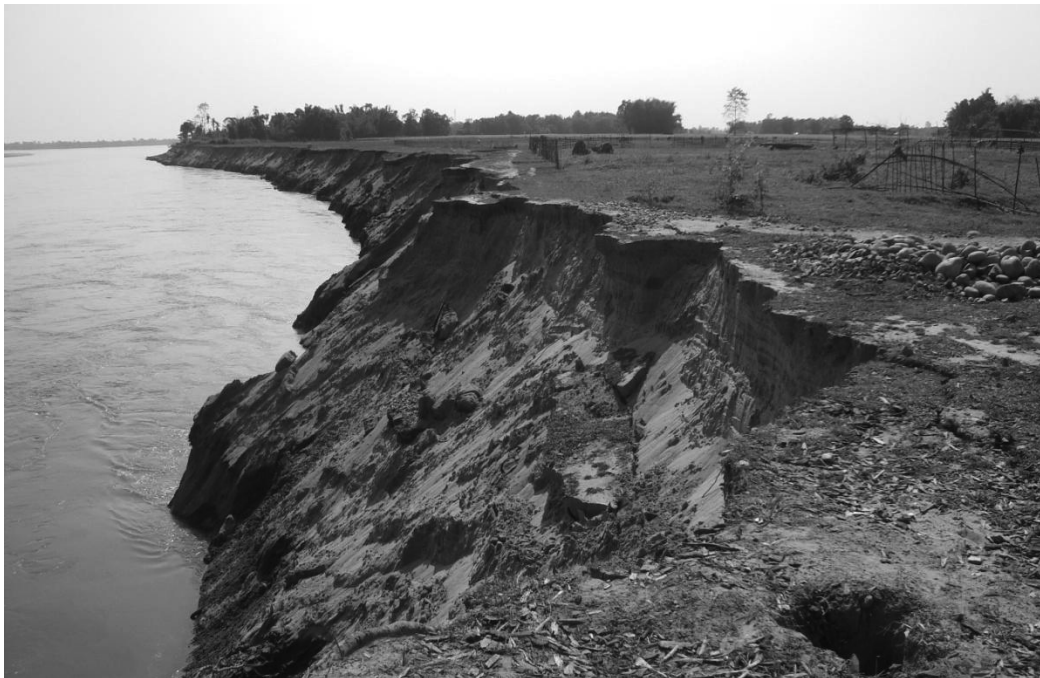
Plate 6.14: Bank erosion of the Subansiri river in Kamalpur area, 2012
